# **EVALUATION OF A HYDROHANDLING SYSTEM FOR SORTING AND SIZING APPLES FOR STORAGE IN PALLET BOXES**

**Marketing Research Report No. 948**

**Agricultural Research Service  
UNITED STATES DEPARTMENT OF AGRICULTURE  
In Cooperation With  
Michigan State University Agricultural Experiment Station**

By D. H. DEWEY, *professor of horticulture*, and B. A. STOUT, *professor of agricultural engineering*, Michigan State University; and JOSEPH F. HERRICK, JR., *investigations leader*, Transportation and Facilities Research Division, Agricultural Research Service

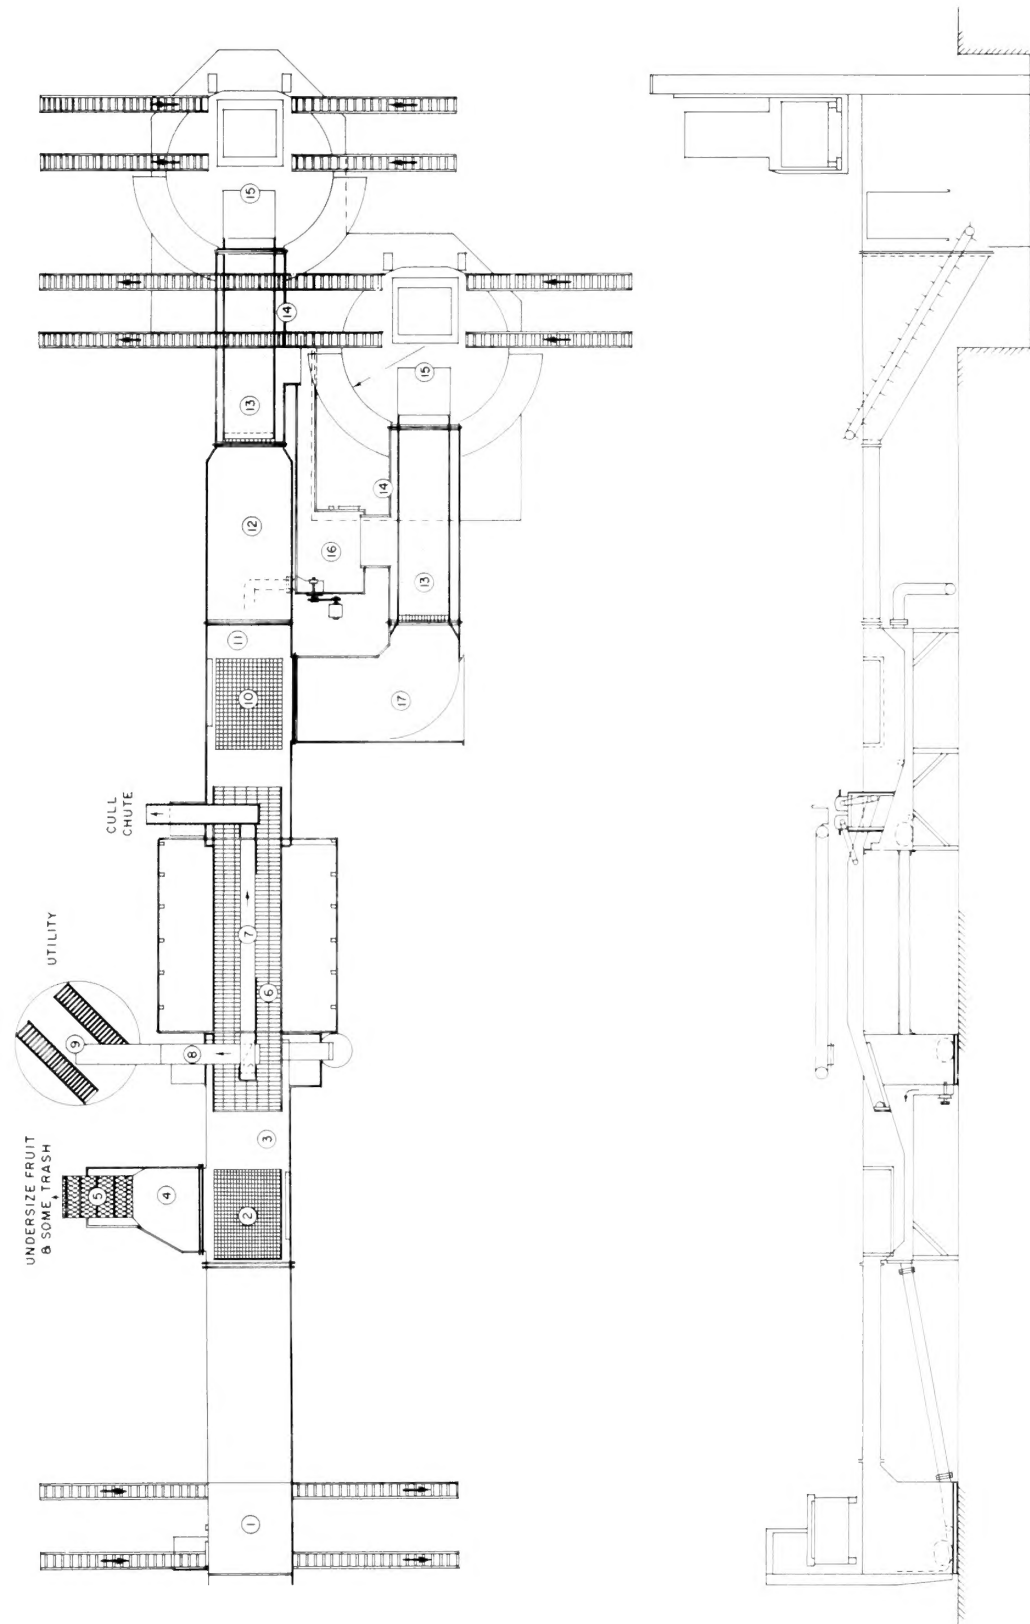
FIGURE 1.—Prototype hydrohandling system showing (1) flotation dumper, (2) hydroeliminators, (3) continuation of dumper tank, (4) lateral flume, (5) flight conveyor, (6) roller sorting table, (7) utility and cull conveyor, (8) dry pallet box filler, (9) hydrosizer tank, (10) hydrosizer, (11) hydrosizer tank, (12) main flume, (13) submerging conveyors, (14) tanks for submerging conveyors, (15) hydrofillers, (16) storage tank for water, and (17) lateral flume.

The purpose of this hydrohandling system is to size and sort apples at a rate up to 600 bushels per hour before placing them in storage. The apples arrive from the orchard in pallet boxes and need to be sized, sorted, and returned to pallet boxes with a minimum of hand labor and bruise damage. The hydrohandling system was described in detail by Stout et al. (9) in 1966. The major components are a flotation dumper, a hydroeliminator, a roller sorting table, a hydrosizer, and two hydrofillers (figs. 1 and 2).

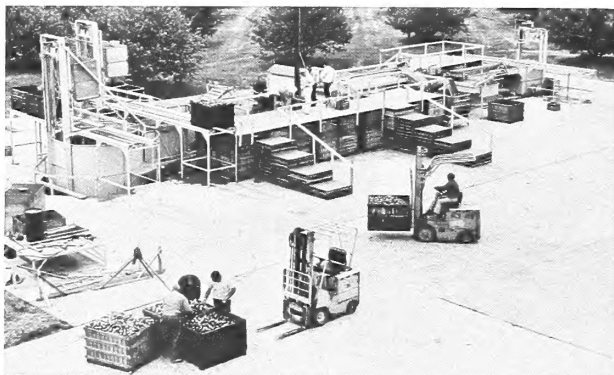
BN-27778

FIGURE 2.—The prototype hydrohandling system. The platforms along the sides were built for observation of tests.

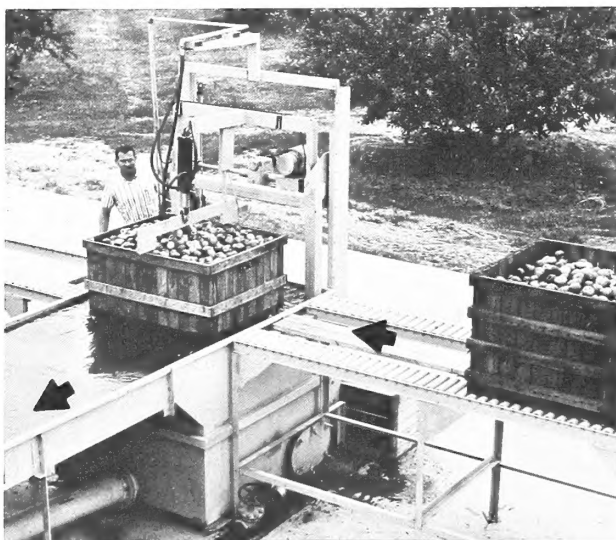
BN-27779

FIGURE 3.—A pallet box of tree-run (unsorted) apples being submerged by the flotation dumper.

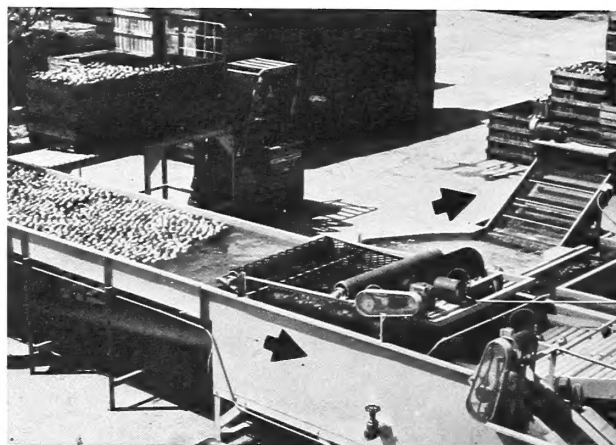
BN-27781

FIGURE 4.—The hydroeliminator at the end of the flotation dumper tank.

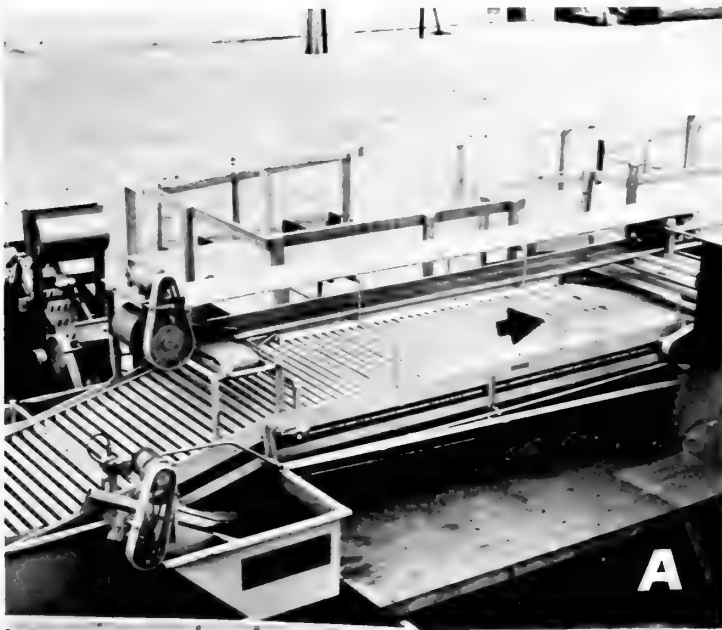
BN-27753 BN-37537

FIGURE 5.—(A) The roller sorting table (lanes were installed later). Utility apples are placed on lower belt above the table and are carried off by a cross-conveyor to a conventional dry pallet box filler (at left rear). Cull apples are placed on the upper belt and are diverted to a gravity chute (not visible in picture) at the end of the sorting table. (B) Cull chutes were added at sides of roller sorting table to increase efficiency of workers.

Workers sorting apples stand on wooden platforms at the sides of the sorting conveyor. The defective fruits are placed on a utility and cull conveyor, which is a closed loop belt above the sorting table. The lower belt is for utility apples which are transferred from the belt to a conveyor and to a dry pallet box filler which places the apples in a pallet box. The cull apples are diverted from the cull belt to a gravity flow chute leading into a pallet box. Cull chutes were provided at the sides of the table to increase the capacity and efficiency of the workers.

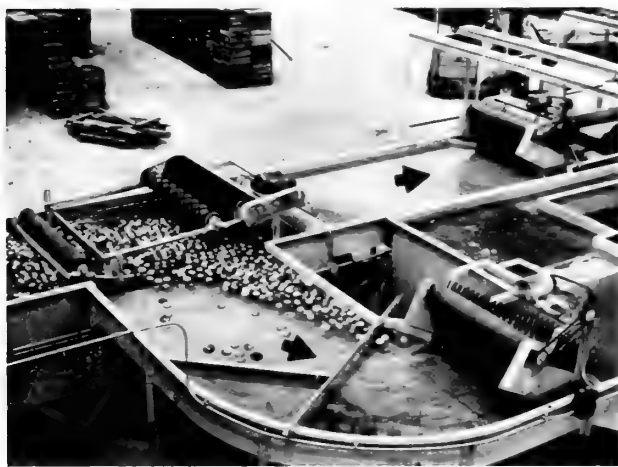
BN 785

FIGURE 6.—The hydrosizer. Apples are returned to water from the sorting table for separation into two sizes by the hydrosizer.

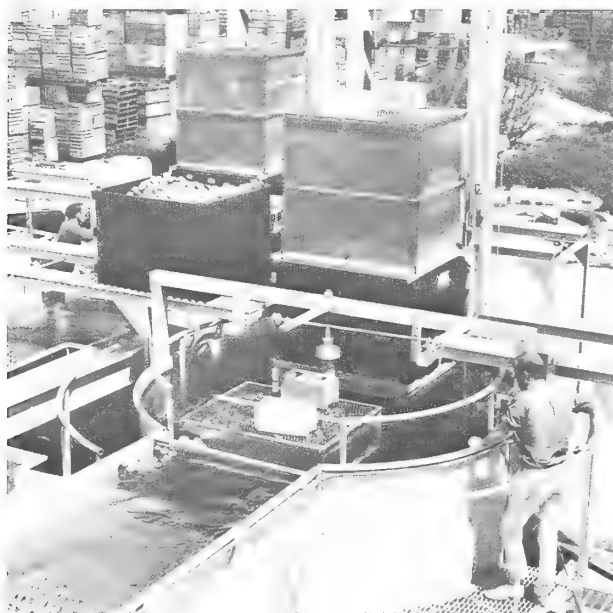
BN-27786

FIGURE 7.—The accumulator of the hydrofiller in the foreground is being filled with apples by the submerging conveyor. The second accumulator has been lifted from the water tank, together with a pallet box. The fruit is transferred to the box as it is raised above the water surface. (Grills and blocks were placed on the accumulators for testing.) A previously filled pallet box is shown to the left on a set of roller conveyors.

feet in diameter and 8 feet 10 inches deep. The submerging conveyor carries the apples down into the water and allows them to float up into the accumulators. Each accumulator is 36 inches wide, 44 inches long, 50 inches high, and has a capacity of 25 bushels. While in the tank, the accumulators rest on a frame mounted on a spindle that permits 180° rotation.

The lift mechanism, similar to the lift on the hydrodumper, is mounted opposite to the submerging conveyor in the tank. This lift submerges a pallet box beneath the accumulator in the tank.

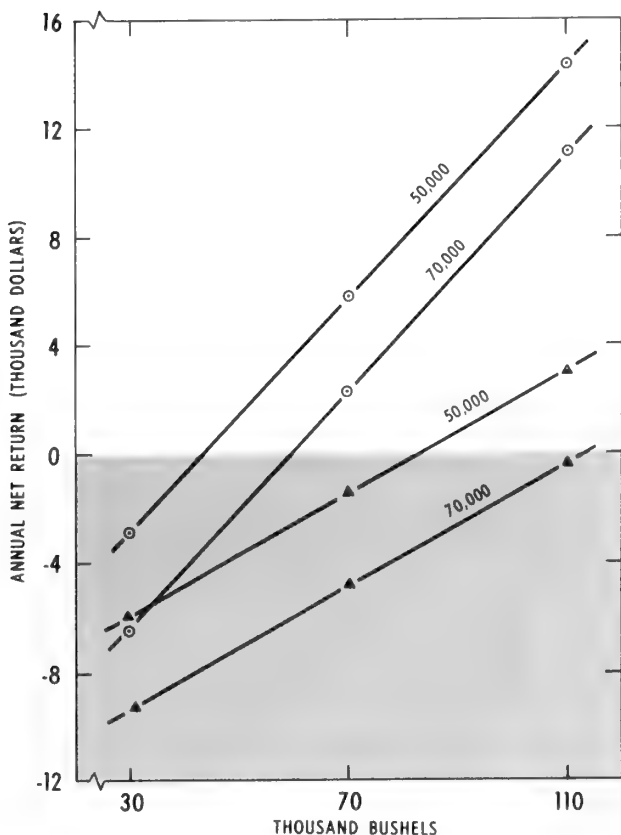
FIGURE 8.—The projected effects of gradeout percentages, initial cost of equipment, and total volume of fruit on annual net return from prestorage sizing and sorting of apples, with 50 percent each of Jonathan and McIntosh supplied at 300 bushels per hour and sized and sorted with an efficiency of 65 percent.

○: gradeout of 70 percent as U.S. No. 1 or better grade, 20 percent as U.S. Utility grade, and 10 percent as culls.

The effects of gradeout percentages and cost of the system (fig. 8) show that as the apples of higher quality are used the net return decreases. This is an important factor to consider when the apples arrive at the storage plant. A quick check on quality should be made to determine whether potential gradeout is high enough to justify the operation. As the initial cost of the equipment increases, the projected net return decreases.

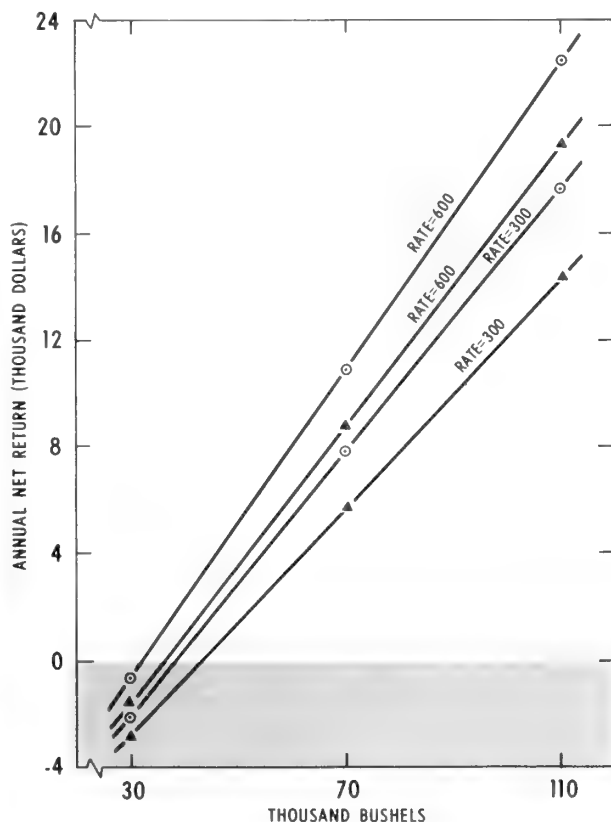
FIGURE 9.—The projected effects of sizing and sorting efficiency, operating rate, and total volume of fruit on annual net return from prestorage sizing and sorting of apples, with 50 percent each of Jonathan and McIntosh, having a sortout of 70 percent U.S. No. 1 or better, 20 percent U.S. Utility, and 10 percent culls using equipment of an initial cost of \$50,000.

○: sizing and sorting efficiency of 65 percent.

Figure 9 shows that higher efficiencies of sizing and sorting will yield a greater net return for the operation. This is due to the increases in savings on storage costs and potential storage gains due to the value increase of the fruit during storage. Increased operating rates also increase net return, especially as the volume of the apples is increased.

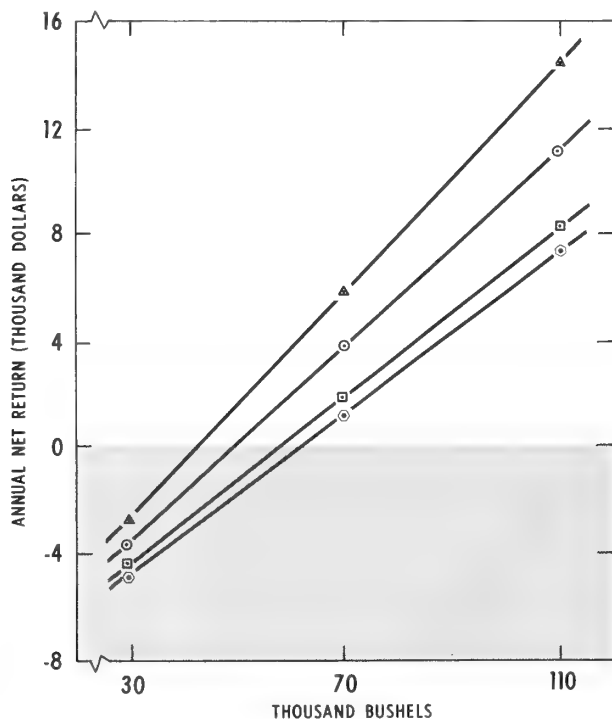
FIGURE 10.—The projected effects of mixture of varieties and total volume of fruit on annual net return from prestorage sizing and sorting of apples, with a sizing and sorting efficiency of 65 percent, a sortout of 70 percent U.S. No.1 or better grade, 20 percent U.S. Utility grade, and 10 percent culls, and a rate of 300 bushels per hour using equipment with an initial cost of \$50,000. Mixture of varieties, in percent:

Symbol on figure	Delicious	Jonathan	McIntosh
○	25	30	45
▲	0	50	50
□	50	0	50
◈	50	50	0

The mixture of varieties of fruit utilized in the system affects the net return (fig. 10). The Jonathan and McIntosh varieties are more likely to justify prestorage sizing and sorting because their increase in value for U.S. No. 1 and better grades is greater than for Red Delicious (table 1).

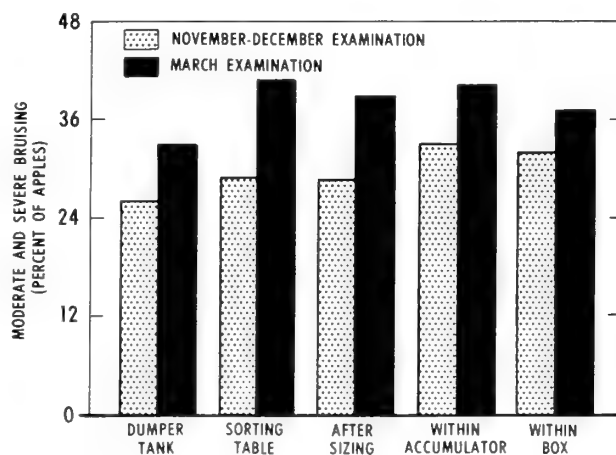
FIGURE 11.—Relative total bruising damage to apples removed from hydrohandling system at various points and held in cold storage in 1967-68.

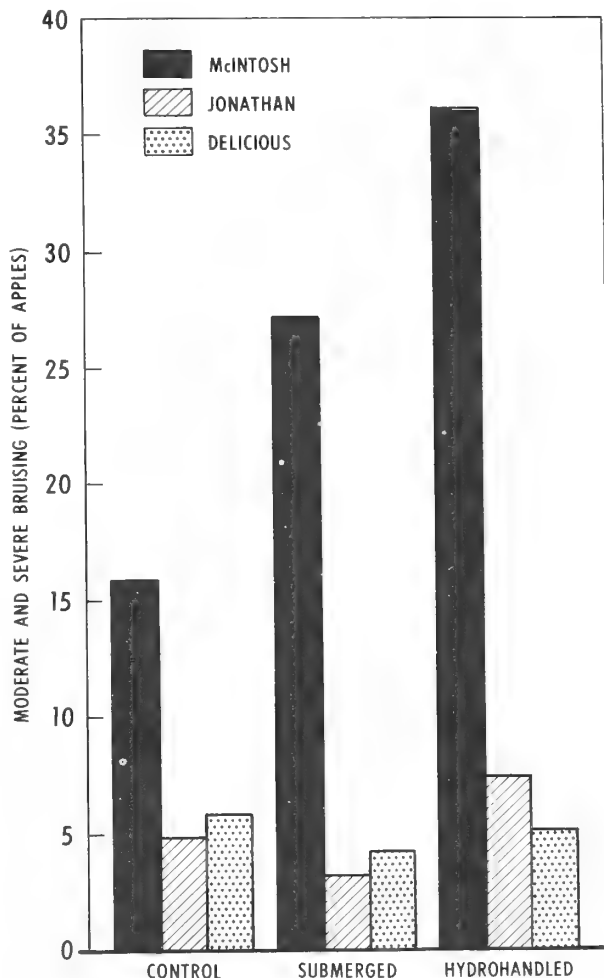
FIGURE 12.—Bruising damage to apples after C.A. storage in relation to prestorage handling treatment and variety in 1967-68.

McIntosh apples were seriously damaged by bruising as a result of submerging and hydrohandling (fig. 12), whereas the Jonathan and Delicious apples were not. Damage to McIntosh by all of the treatments exceeded the corresponding treatments of the other two varieties by highly significant amounts. Control (untreated) McIntosh had approximately 16 percent of the fruit damaged by bruising; to this, the relatively careful submerging treatment in the enclosed pallet box increased the number of damaged apples by approximately 11 percentage points. The hydrohandling system caused an increase of 20 percentage points in bruising over the control so that over 36 percent were found to be damaged when the apples were dumped after removal from storage. The maximum percentage of bruised apples for Jonathan was 7.5 percent, for Delicious slightly less than 6 percent. For these varieties, there were no significant treatment differences.

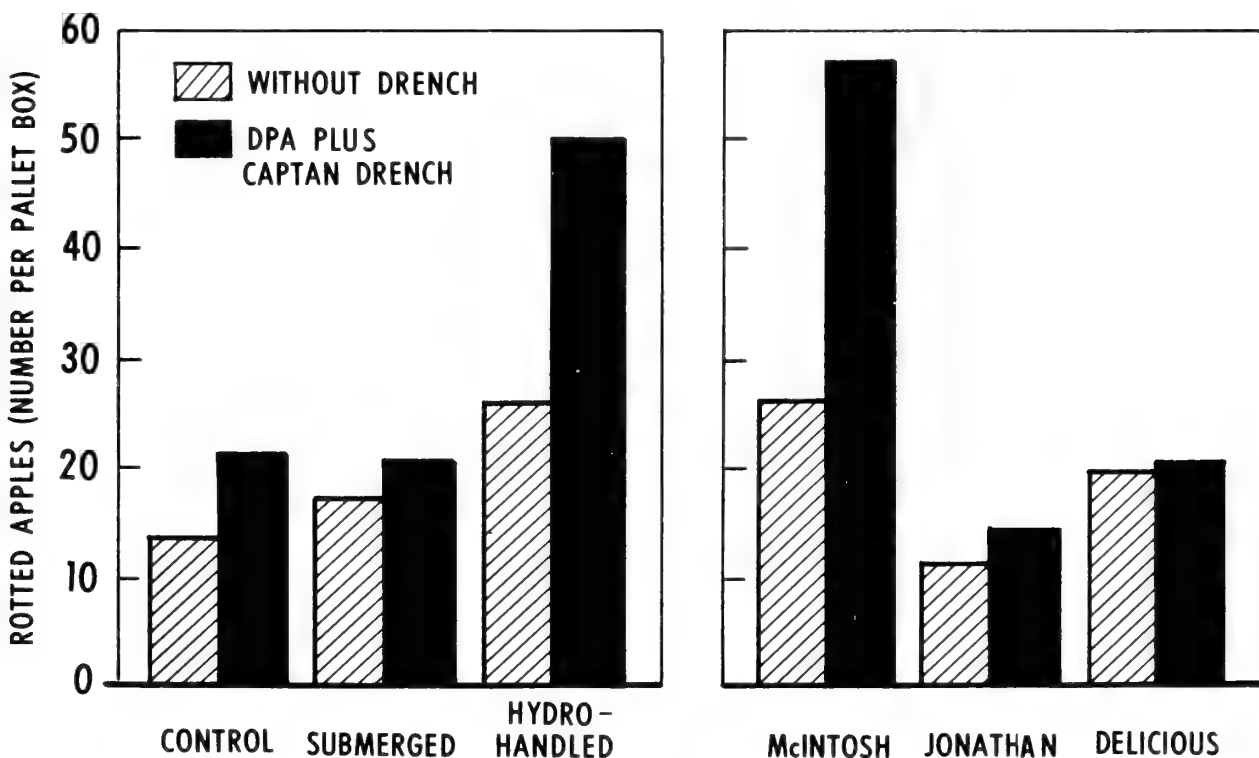
FIGURE 13.—Relative number of apples developing rot during C.A. storage as affected by handling treatment and variety in 1967-68.

The relative amounts of fruit rot as determined by count of affected apples per bin are plotted for varieties and handling treatments in figure 13. Hydrohandling caused a highly sig-

nificant increase in fruit rot over submerging and control (fig. 13, left), whereas the submerging and control treatments were similar. For varieties (fig. 13, right), McIntosh exceeded the others by highly significant amounts. Jonathan and Delicious did not differ in decay. Drenching the fruit with a DPA and captan solution increased rotting of apples over those which received no drench treatment; apparently, the captan was of inadequate strength to prevent a buildup of viable disease inoculum in the drench solutions. Significant interactions occurred for "Handling treatments  $\times$  Drench treatments" and for "Variety  $\times$  Drench treatments" (fig. 13). As previously shown for bruising, the McIntosh apples were particularly susceptible to rot after passing through the hydrohandling system.
